Flood Warning Systems

A Case Study of Frijoles Canyon

Mike Zucosky
Director of Operations
April 16, 2015

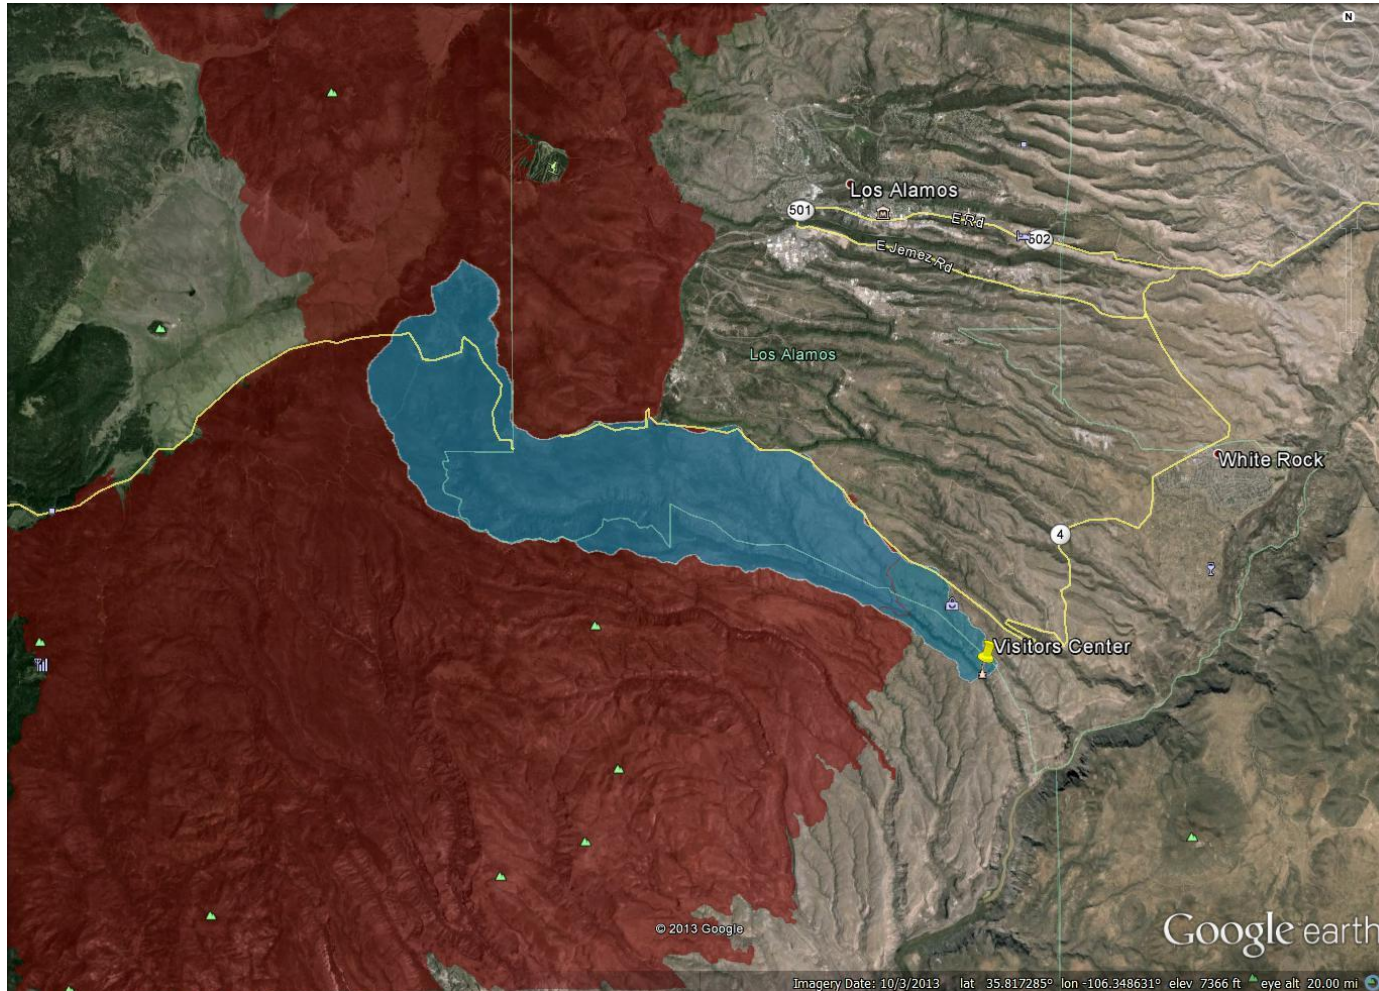
Las Conchas Fire – Frijoles Canyon Watershed

- June 26th, 2011
 - Largest fire in New Mexico state history (at the time) erupted in the Bandelier National Monument
 - 156,000 acres burned²
 - Estimates of 11,000+ acres burned in the Frijoles Canyon watershed¹
 - Over 75% of the Frijoles Canyon watershed was impacted

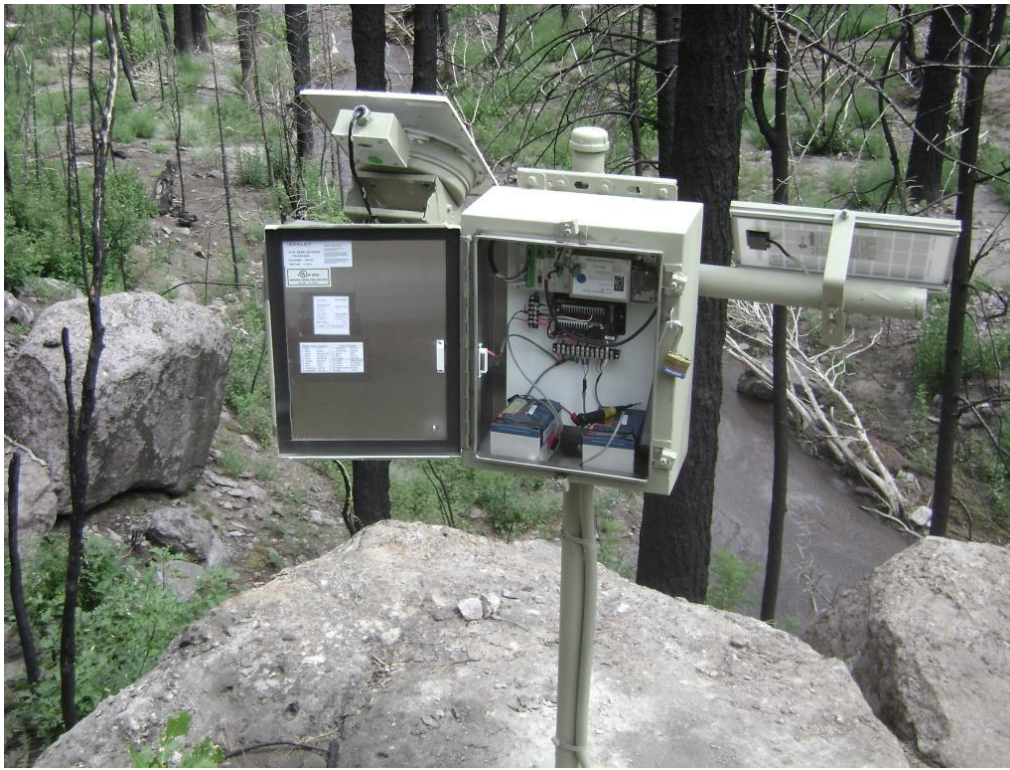
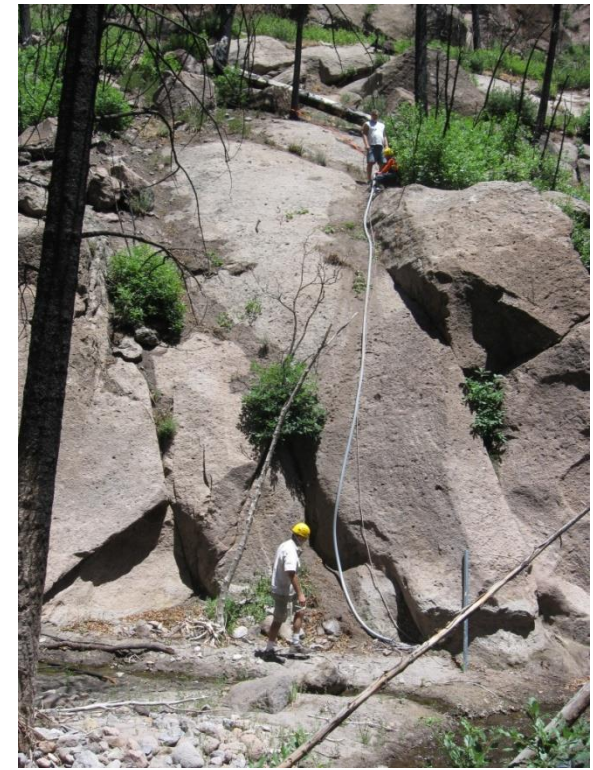
Photos provided by USGS

- Electronics, telemetry equipment, sensors and software were provided by OneRain and installed by the USGS

- 2 Rain Gauges and 1 Stream Gauge installed in the upper portion of the Frijoles Canyon
 - Too remote for a traditional VFH or Spread Spectrum solution; no cellular reception
 - For real-time data with guaranteed delivery, a private satellite network was selected

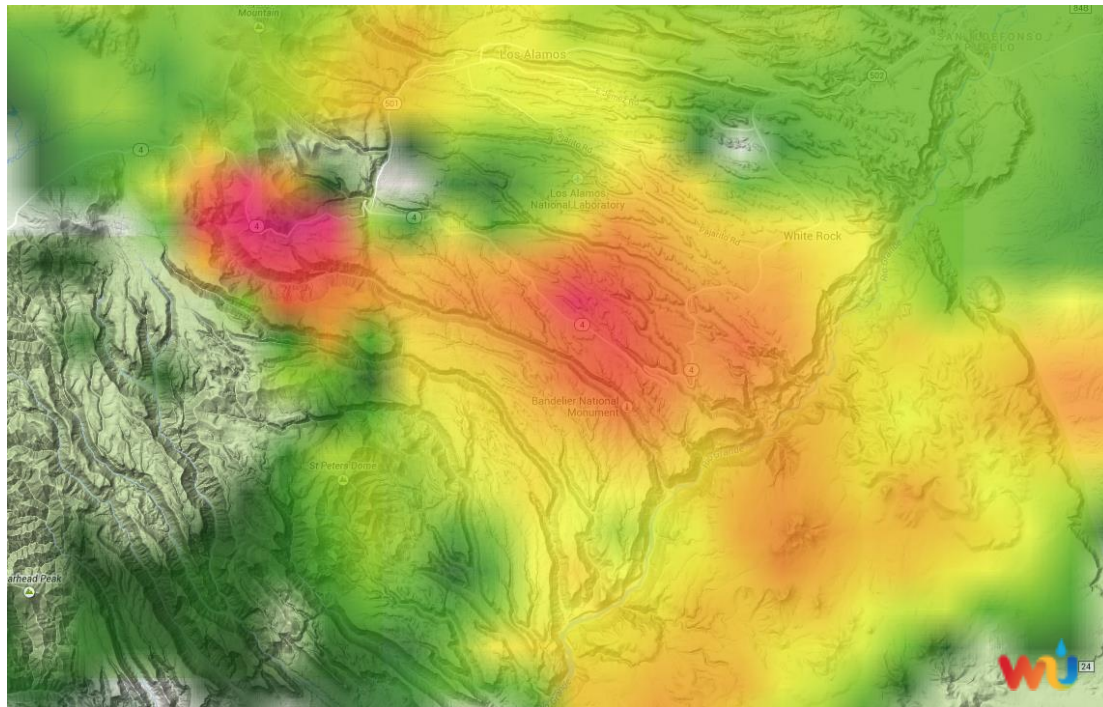
Radar Reflectivity from Jul 25, 2013 23:25 MDT
Image from Weather Underground

- July 25th – 26th, 2013
 - Rains in the Frijoles begin at 11:06 PM MDT
 - Short event, but intense rainfall started at 11:23 PM MDT

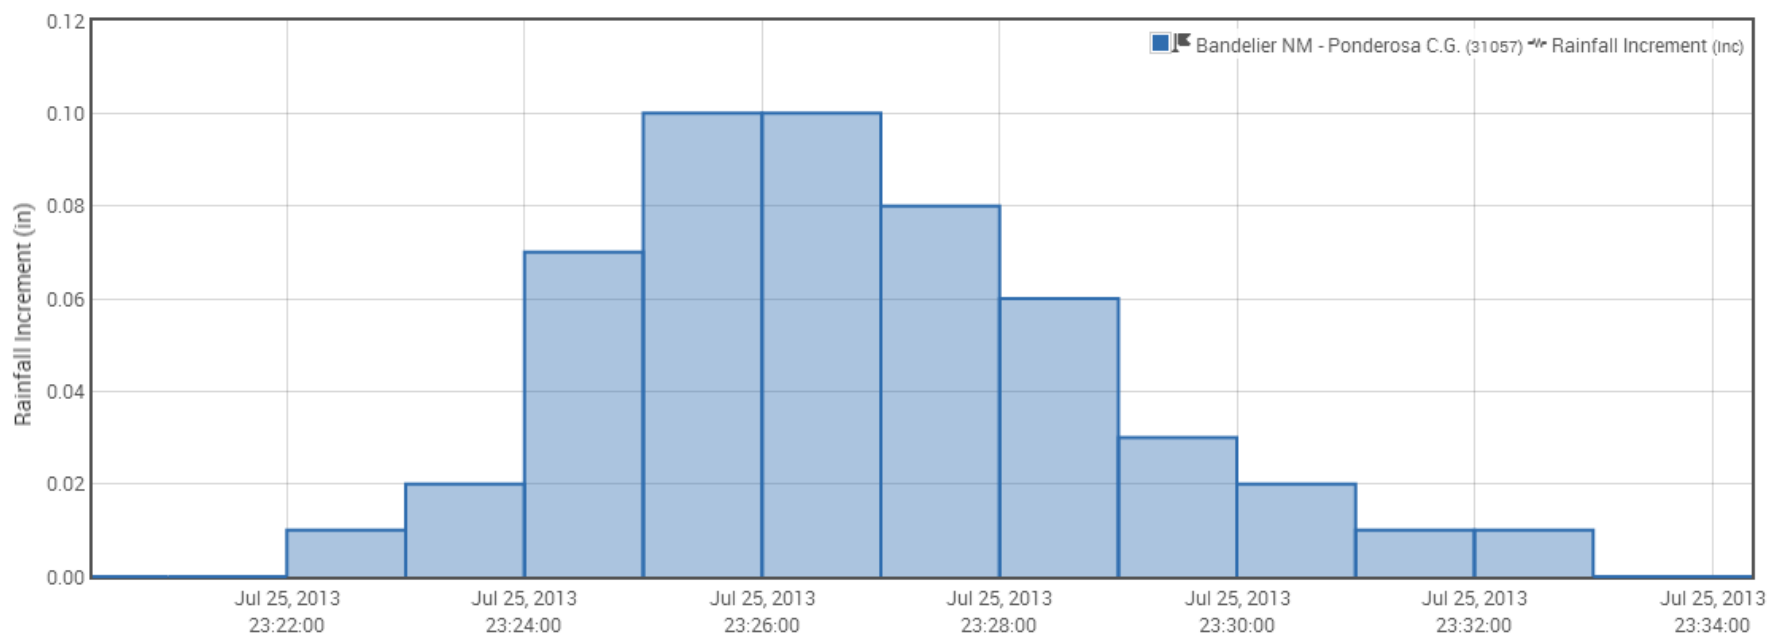
- Ponderosa Campground
 - 0.50-inches in 11 minutes
 - 1-minute grouping of rainfall data:

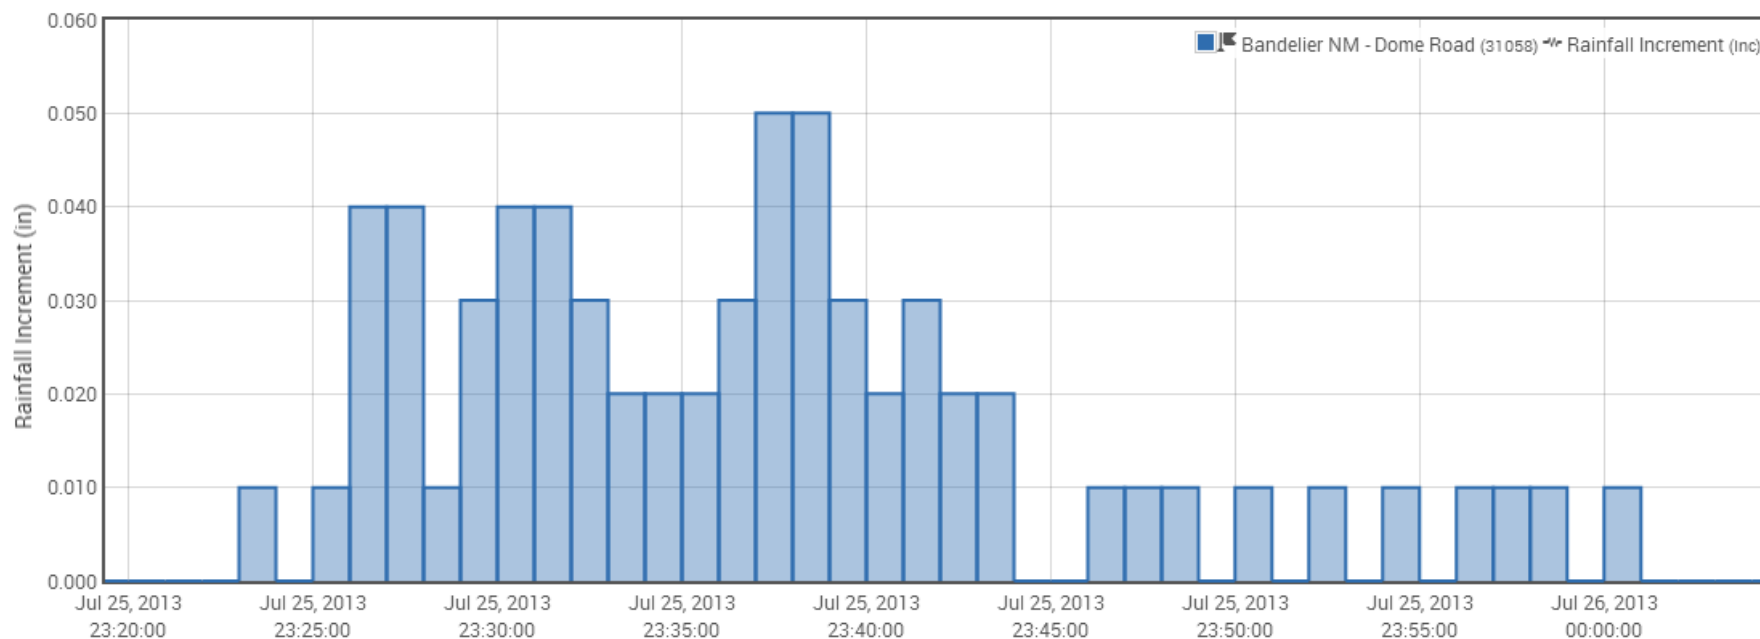
- Dome Road
 - 0.65-inches in 36 minutes
 - 1-minute grouping of rainfall data:

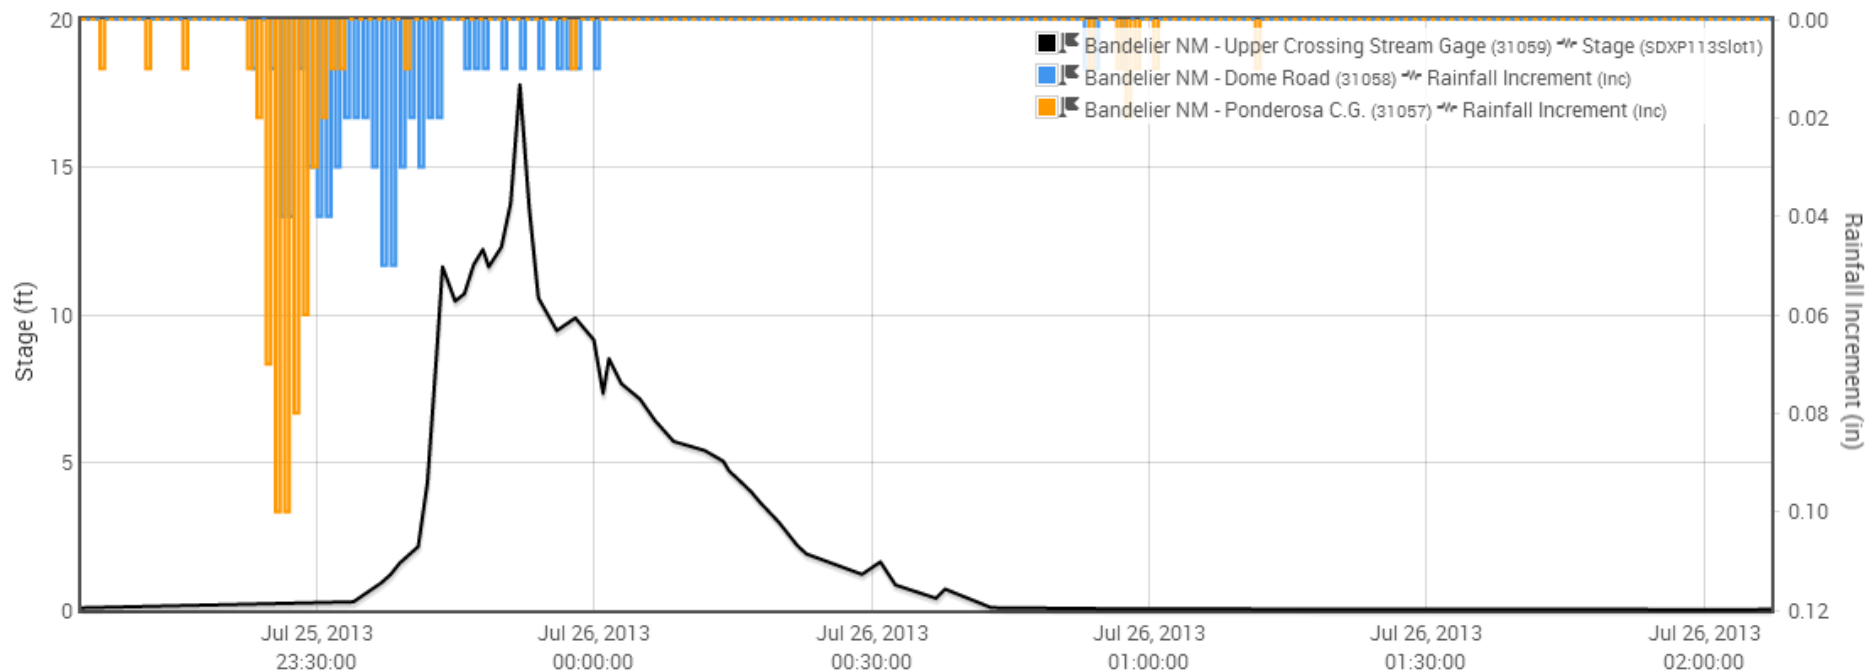
- Upper Crossing Stream Gauge
 - 36 minutes after rain began, stream began to rise
 - Max. stage height: 17.78 feet

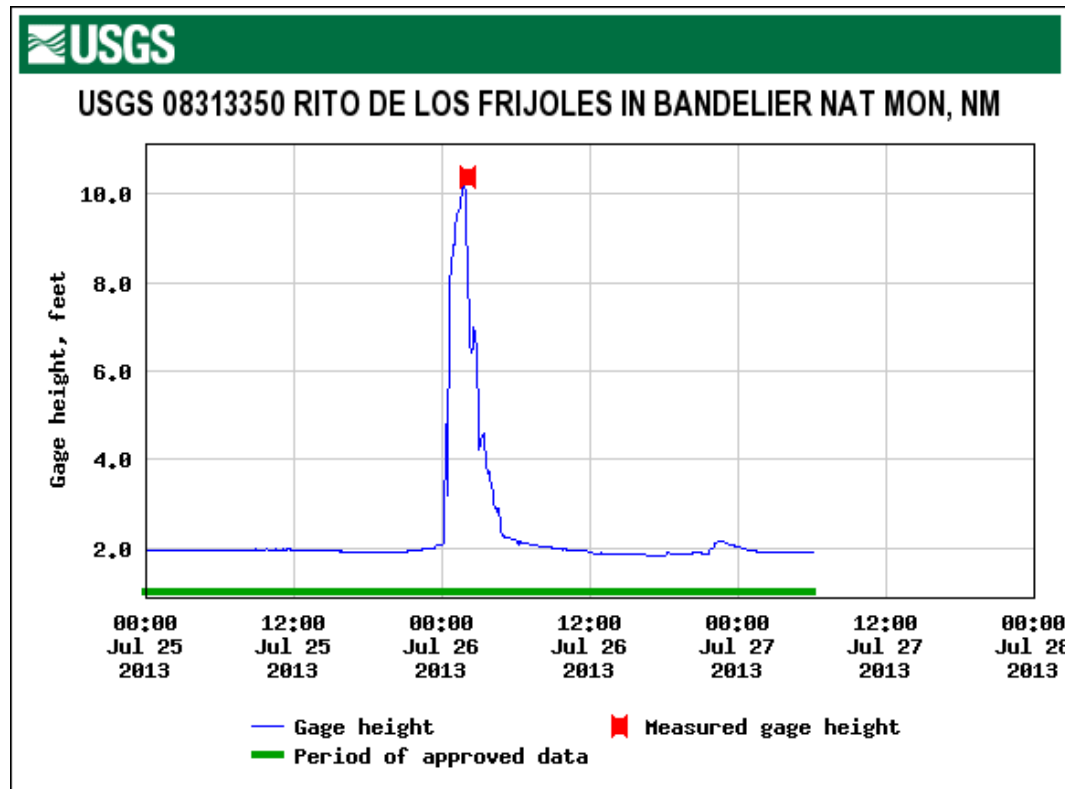
- USGS Stream Gauge
 - Downstream of Visitor Center
